Case Study:

GE Magne-Blast Medium Voltage Circuit Breaker Repair Tech

Trip Shaft Bearing Replacement in GE Magne Blast Medium Voltage Breaker for Large Metropolitan Utility Company

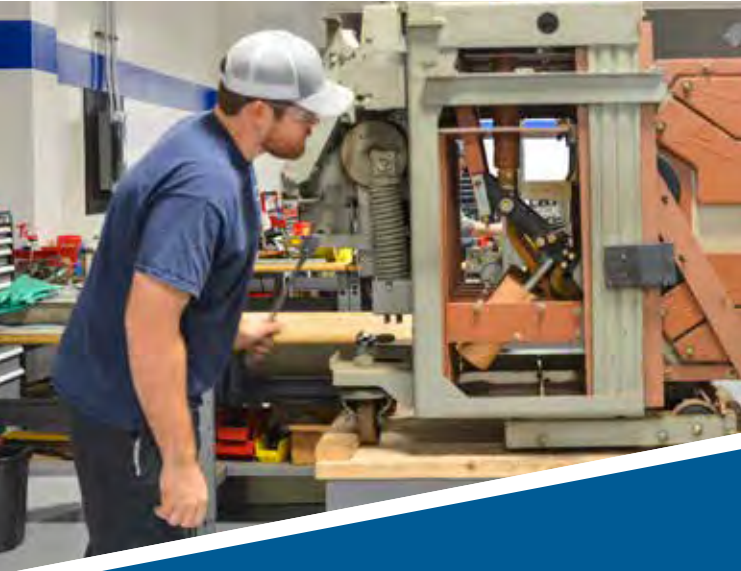
A utility company in a large metropolitan area reported that the trip shaft bearings seized in the mechanism of a GE Magne-Blast medium voltage circuit breaker. The result was numerous failure-to-trip situations, which led to bus lockouts and major service interruptions to the metropolitan area utility customers. There was a clear need for urgent repair.

The Quad Plus Shop Manager worked closely with the customer to develop a Method of Procedure to replace the trip shaft bearings in the mechanism without having to remove the mechanism from the breaker or remove the breaker from the customer's site. This specialized procedure was necessary to expedite the industrial circuit breaker repair, as the customer could only tolerate the shortest amount of downtime.

To complete the new procedure, our Shop Manager provided training for the customer's electricians on the removal of the trip shaft bearing linkage. That way, the linkage could be brought immediately to our shop for bearing replacement, and returned to the customer quickly to be reinstalled in their medium voltage circuit breaker.
